## PCB Source Control Investigation of the City of Tukwila Stormwater System

Jorgensen Pipe Discharge Area  
City of Tukwila, WA

December 2008  
Project No. 40407.011

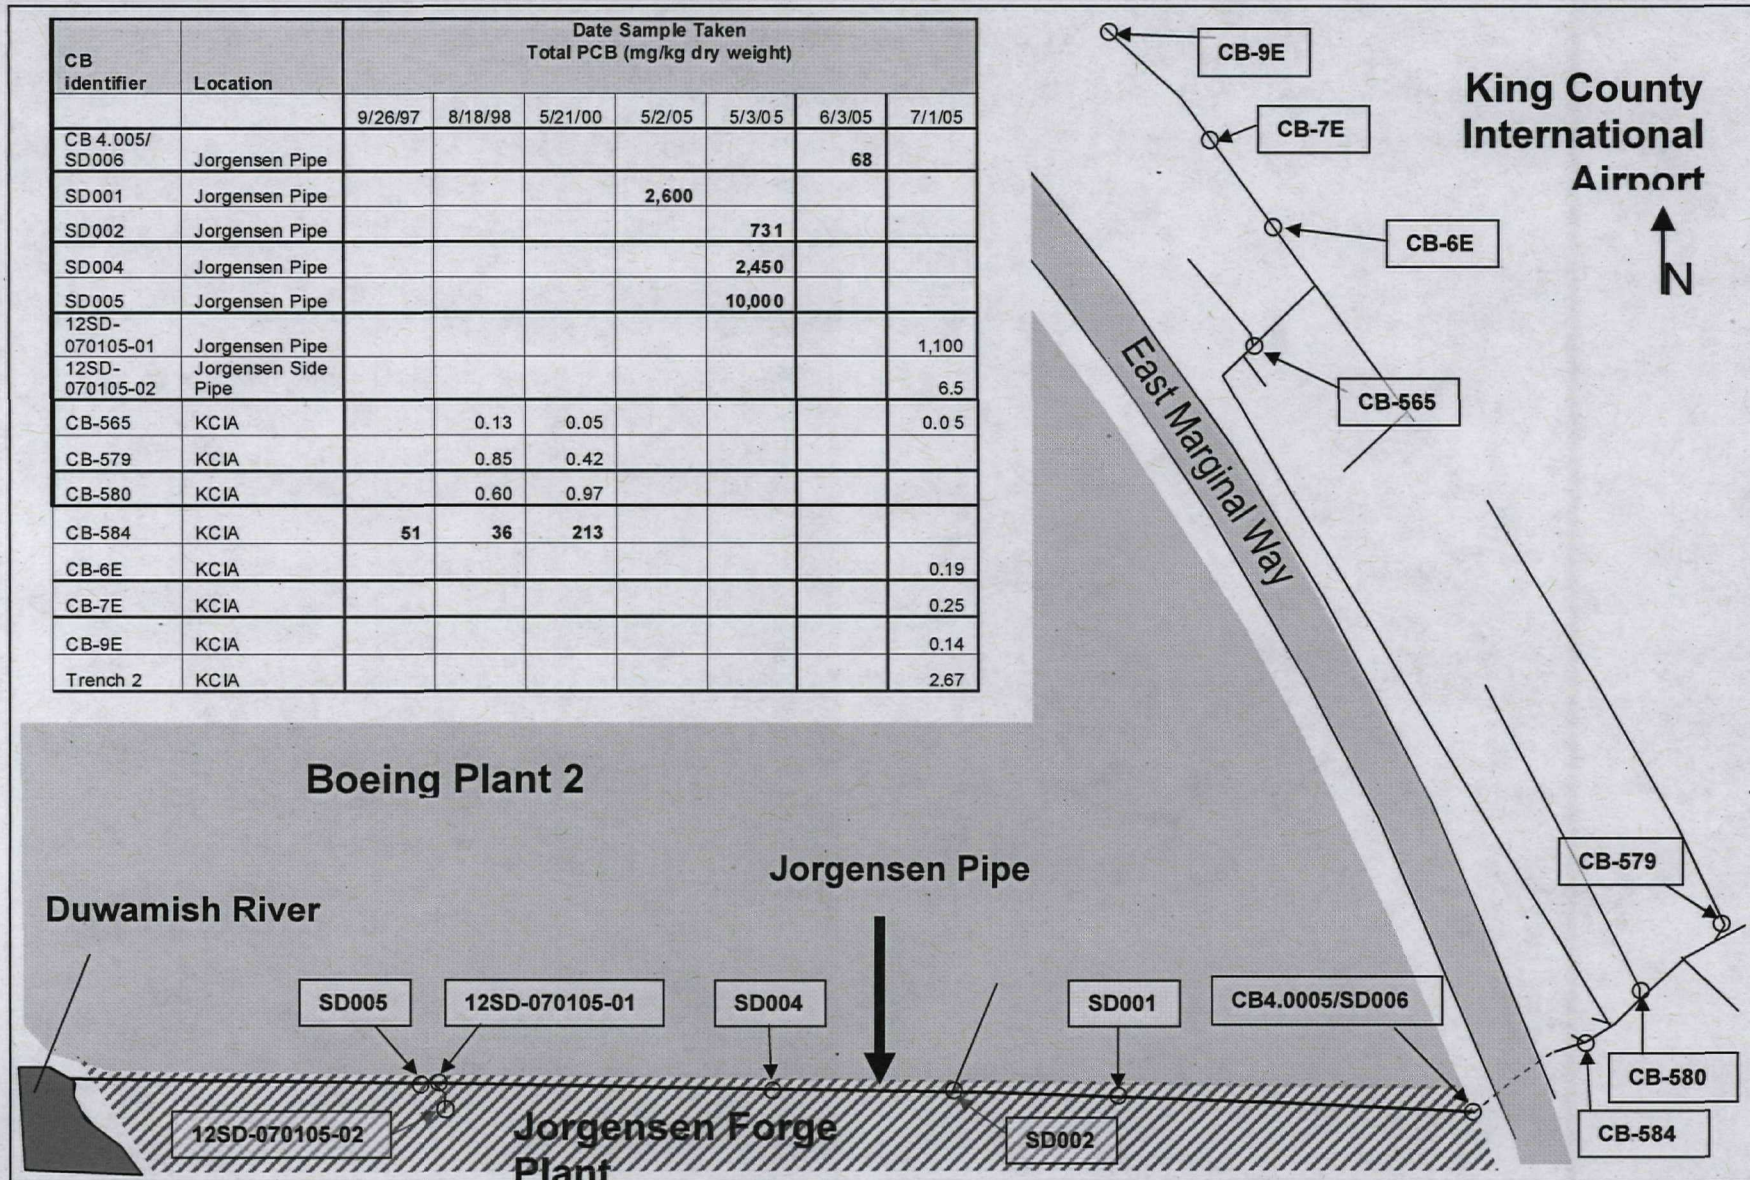
Figure 3: Previous PCB Sampling Locations and Results

**Table 1.** Levels of PCBs from Sediments Sampled in the Jorgensen Pipe and King County International Airport Storm System from Previous Investigations.

CB identifier	Location	Date Sample Taken Total PCB (mg/kg dry weight)						
		9/26/97	8/18/98	5/21/00	5/2/05	5/3/05	6/3/05	7/1/05
CB 4.005/ SD006	Jorgensen Pipe						<b>68</b>	
SD001	Jorgensen Pipe				<b>2,600</b>			
SD002	Jorgensen Pipe					<b>731</b>		
SD004	Jorgensen Pipe					<b>2,450</b>		
SD005	Jorgensen Pipe					<b>10,000</b>		
12SD- 070105-01	Jorgensen Pipe							<b>1,100</b>
12SD- 070105-02	Jorgensen Side Pipe							6.5
CB-565	KCIA		0.13	0.05				0.05
CB-579	KCIA		0.85	0.42				
CB-580	KCIA		0.60	0.97				
CB-584*	KCIA	<b>51</b>	<b>36</b>	<b>213</b>				
CB-6E	KCIA							0.19
CB-7E	KCIA							0.25
CB-9E	KCIA							0.14
Trench 2	KCIA							2.67

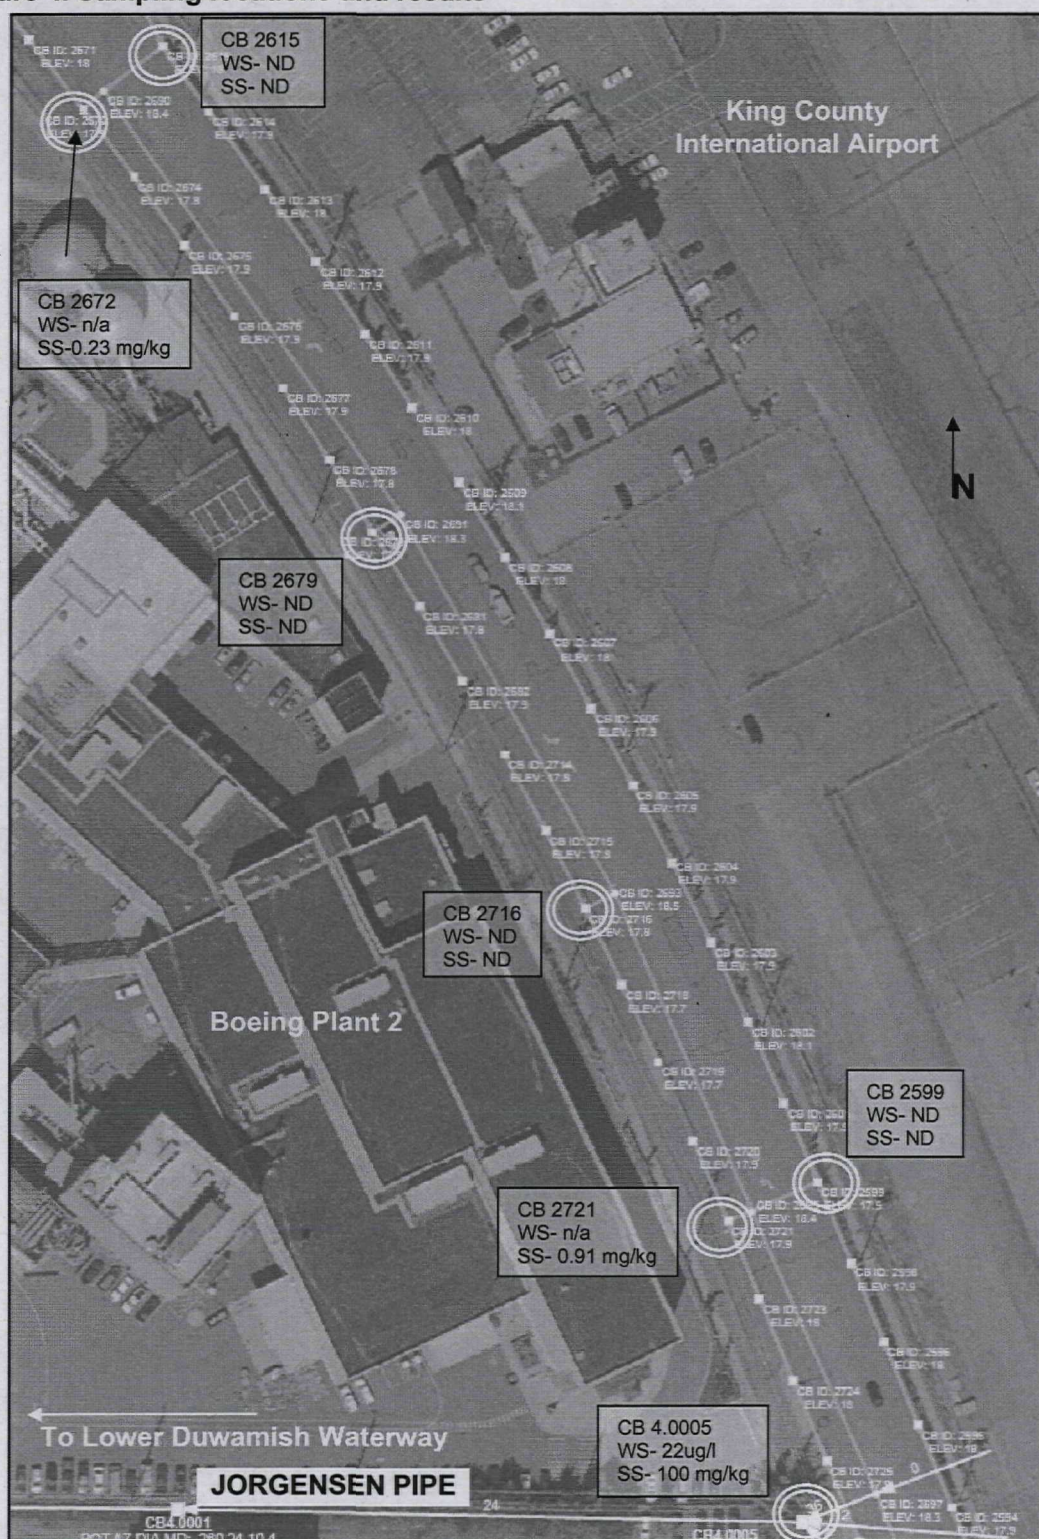
#### Figure 4. Sampling locations and results

Seven sediment samples and five water samples were collected using the methods identified in Section 4.1 from six catchbasins along East Marginal Way and the Jorgensen Pipe manhole. The results from the PCB analysis at NVL are presented below in Table 2 and in Figure 4. Catchbasin reference numbers and locations can also be found on Figure 4.

Sediment samples from catchbasins 2679, 2716, 2615, and 2599 were non-detect for PCBs. Detection levels for the analysis were 0.2 mg/kg. Sediment from catchbasin 2672 contained 0.23 mg/kg dry weight PCB concentration. Sediment from catchbasin 2721 contained 0.91 mg/kg dry

weight total PCB concentration. Total PCB levels found in the Jorgensen Pipe CB measured 100 mg/kg dry weight. The Washington State Sediment Quality Standard for PCBs is 12 mg/kg dry weight and the Cleanup Screening Level is 65 mg/kg dry weight. Samples from catchbasins 2672 and 2721 both contain levels of PCB concentration below the Sediment Quality Standard. The sample from the Jorgensen Pipe location had concentrations ten times higher than the Sediment Quality Standard and above the Cleanup Screening Level. All detectable PCBs were Aroclor 1254.

Water samples from catchbasins 2679, 2716, 2615, and 2599 were non-detect for PCBs. Detection limits for this analysis were 0.1  $\mu\text{g/liter}$ . No water samples were obtained from catchbasins 2672 and 2721 because water was not present during the sampling period. The only elevated PCB concentrations were found in the water sample collected from the Jorgensen Pipe. The sample from this catchbasin had a PCB concentration of 22  $\mu\text{g/l}$ . The acute exposure level is 2.0  $\mu\text{g/l}$ . The chronic exposure level in freshwater is 0.014  $\mu\text{g/l}$  and 0.03  $\mu\text{g/l}$  in saltwater. Water collected from the Jorgensen Pipe exceeded both the acute and chronic exposure levels.

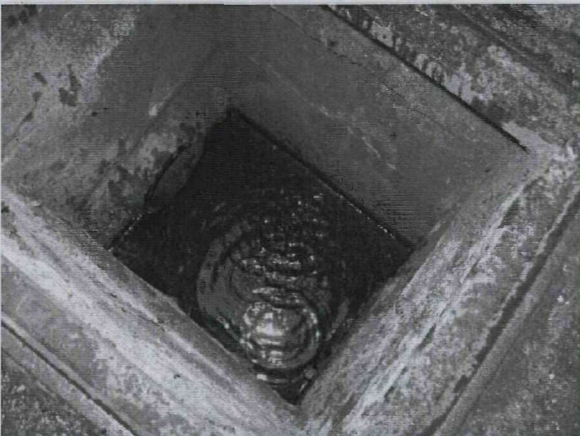
Photo 3. Inside of typical City of Tukwila catch basin in study area

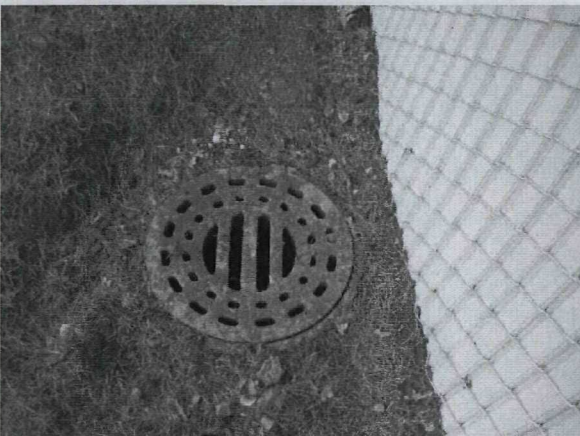
The elevated PCB levels we found in the manhole at the top of the Jorgensen Pipe were consistent with previous measurements at this location and with measurements taken at the KCIA intertie on the opposite side of East Marginal Way. Our sample measured 100 mg/kg, whereas a sample taken in 2005 at the same location had 68 mg/kg. Levels recorded across the street at the King County outfall were 36, 51 and 128 mg/kg dw. During the 2005 sampling effort in the Jorgensen pipe, the recorded level in the manhole at the top of the pipe (68 mg/kg dw) was the lowest level recorded in the pipe. PCB levels further down gradient in the Jorgensen Pipe ranged from 731 to 10,000 mg/kg dw, with the highest level (10,000 mg/kg dw) recorded near the transformer site on Boeing Phase 2 property.

Photo 5. Manhole at top of Jorgensen Pipe along west side of East marginal Way

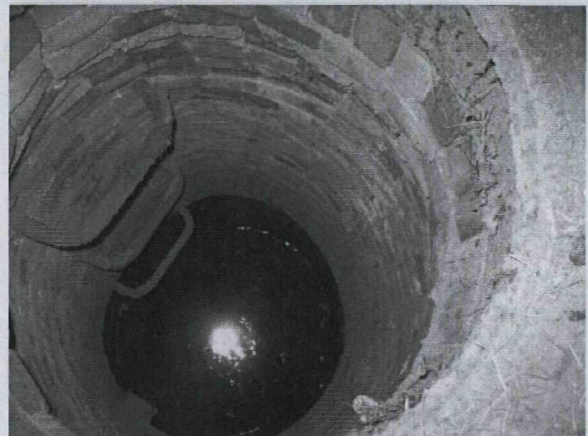
Photo 6. Inside of manhole at top of Jorgensen Forge pipe
